Audit Report

██████████ 2024 Audit of Electrical Heat Trace Systems

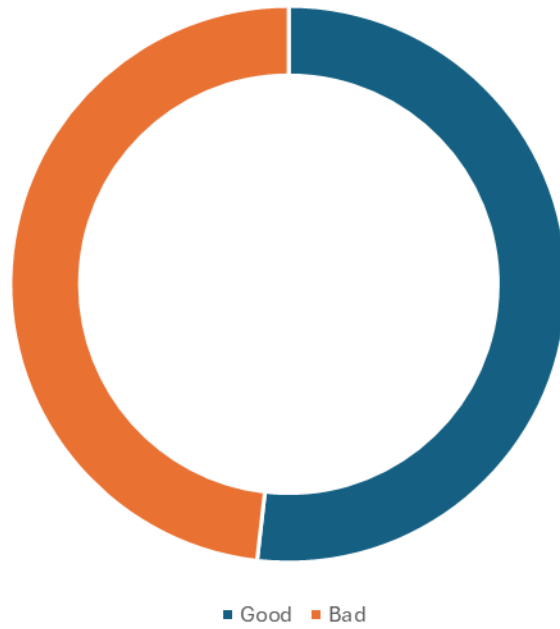
Heat Trace Conditon

The evaluation indicates that 42% of the insulation elements are in good condition, while 22% are in bad condition. Additionally, 18% of the insulation elements are categorized as spares. For heat trace components, 28% are functioning as intended, 35% are in bad condition, and 18% are identified as spares.

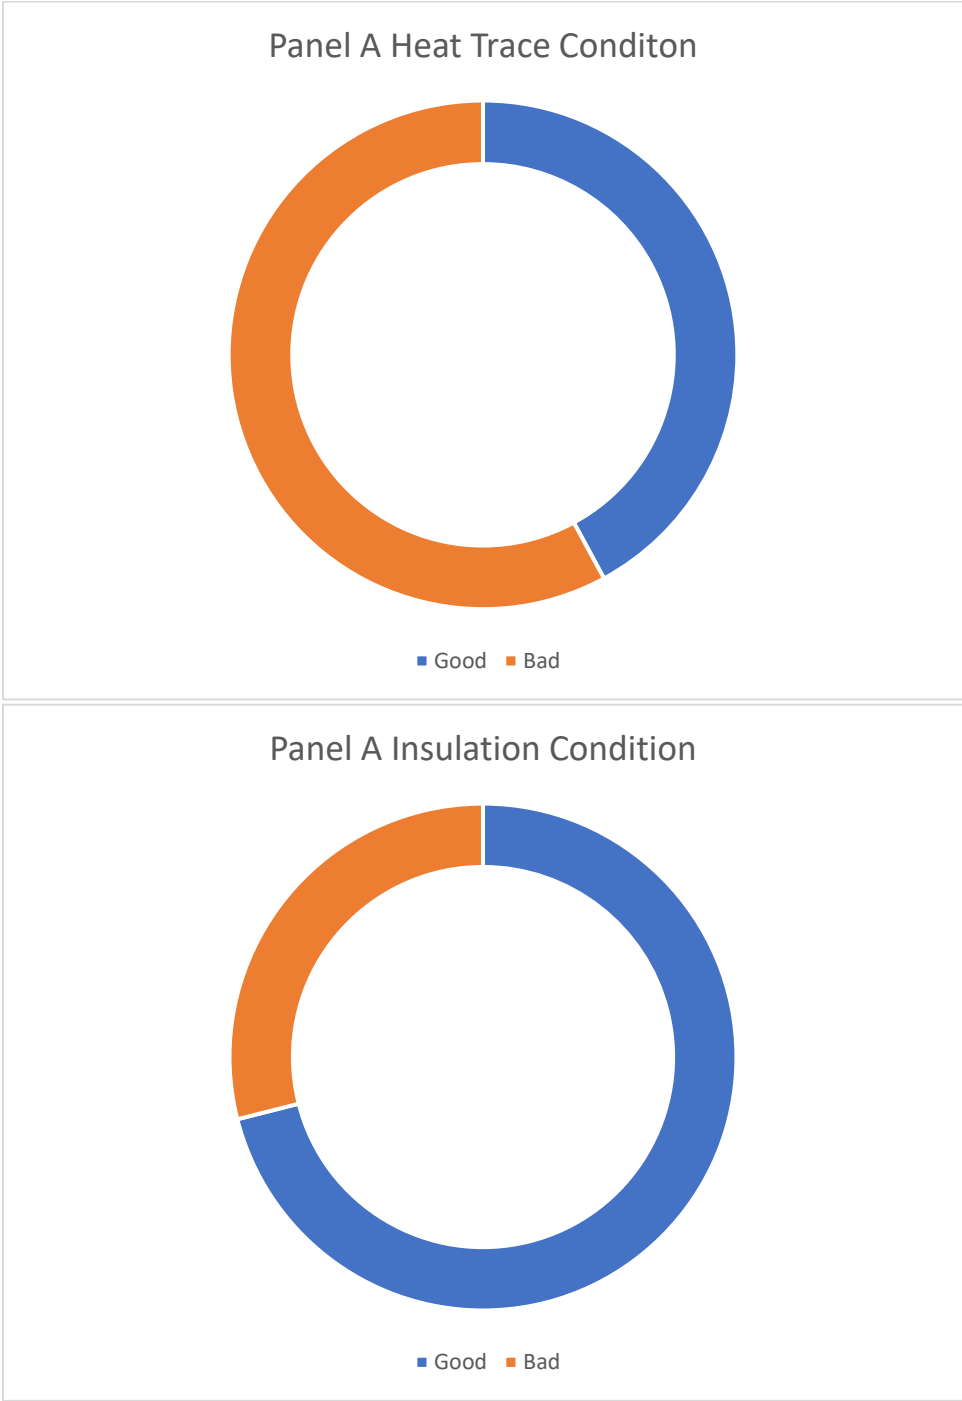
4.1.1 Audit Data

Only 28% of the heat trace components are in good condition, with 72% requiring immediate repair. The insulation components are mostly in good condition at 88%, but 12% need attention.

In summary, Panel A's heat trace system needs significant repairs, while the insulation system requires minor fixes to maintain overall efficiency.

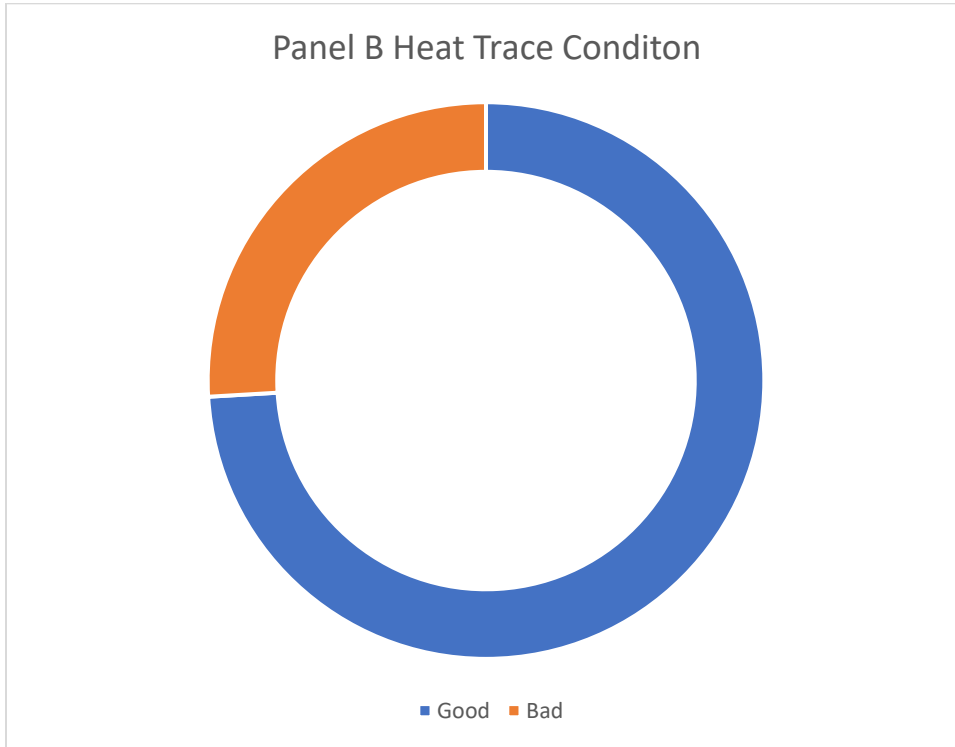
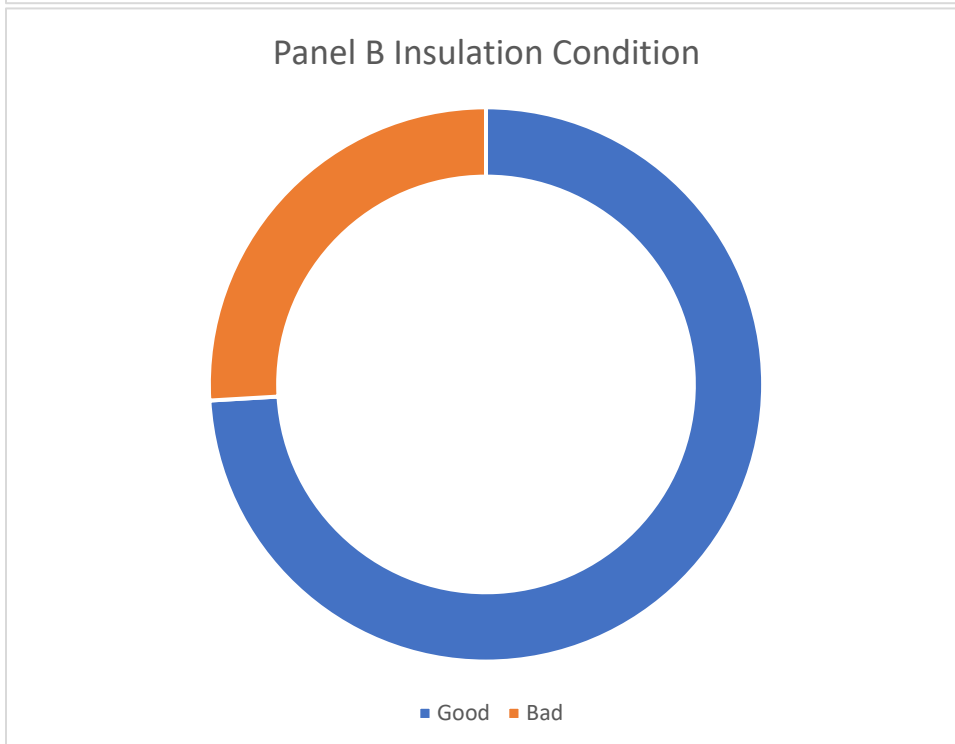
4.2.1 Audit Data

Only 14% of the heat trace components are in good condition, with 86% requiring immediate repair. The insulation components are mostly in good condition at 86%, but 14% need attention.

In summary, Panel B's heat trace system needs significant repairs, while the insulation system requires minor fixes to maintain overall efficiency.

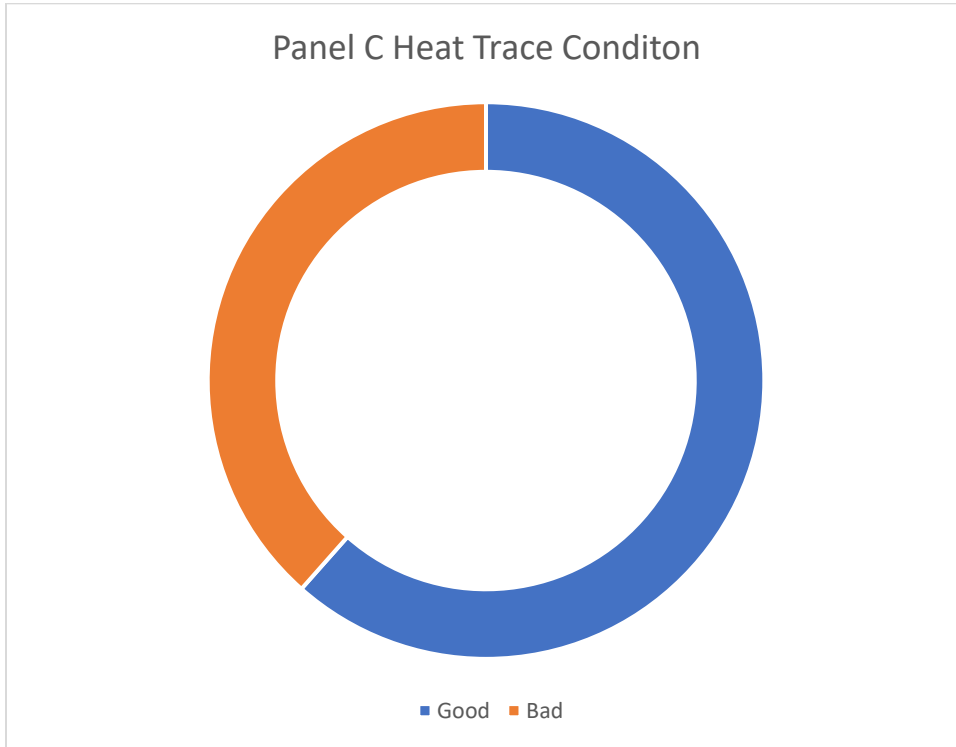
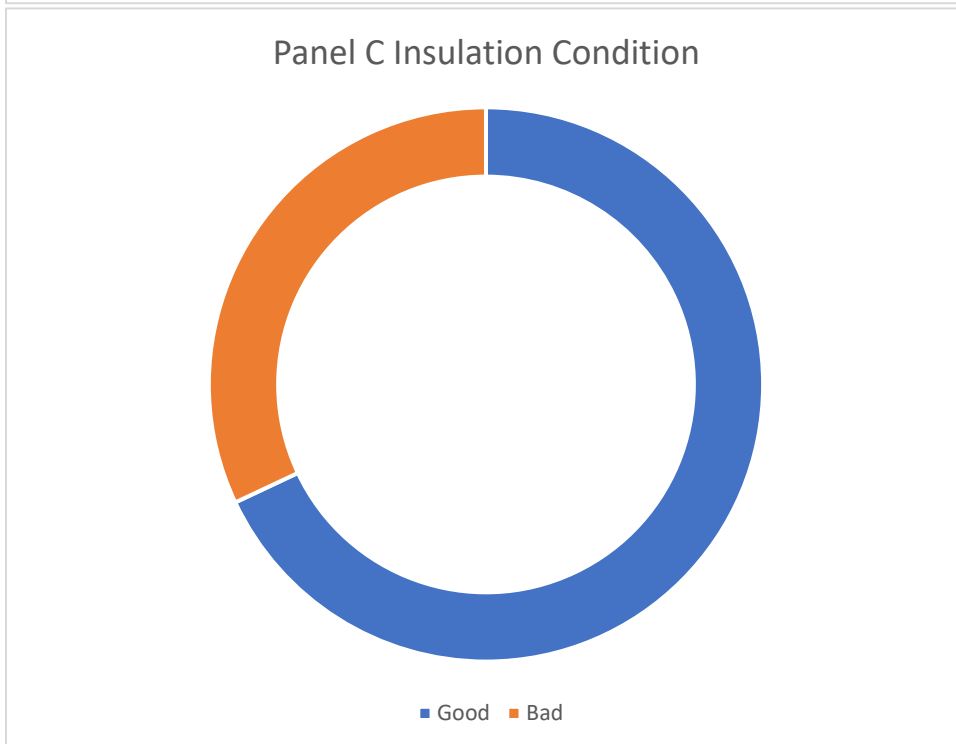
4.3.1 Audit Data

Only 24% of the heat trace components are in good condition, with 76% requiring immediate repair. The insulation components are mostly in good condition at 86%, but 14% need attention.

In summary, Panel C's heat trace system needs significant repairs, while the insulation system requires minor fixes to maintain overall efficiency.

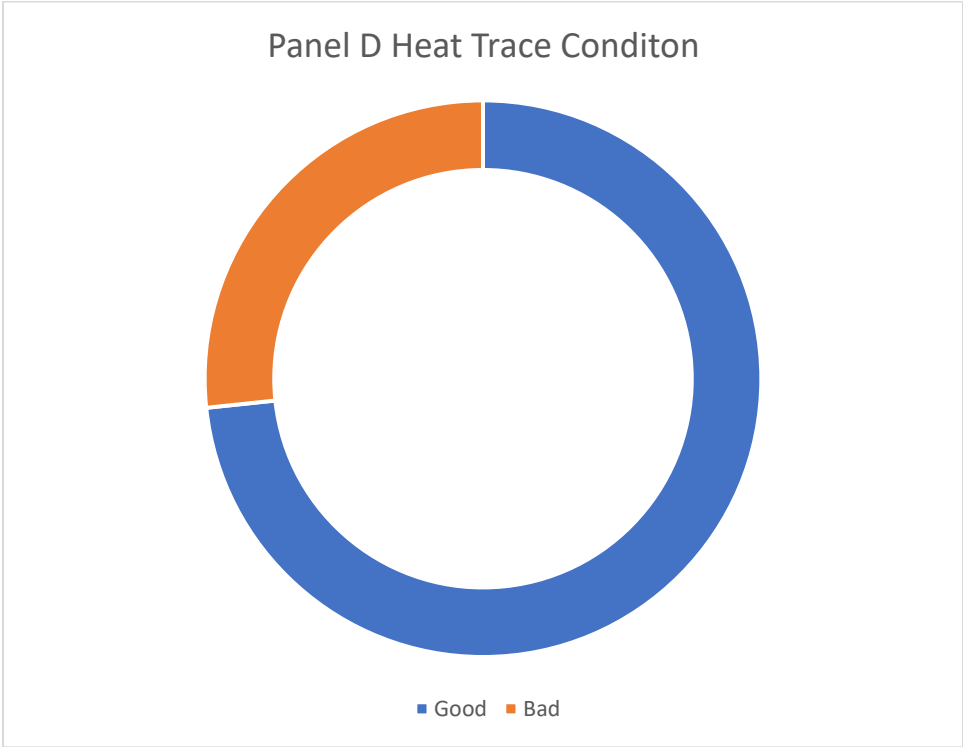
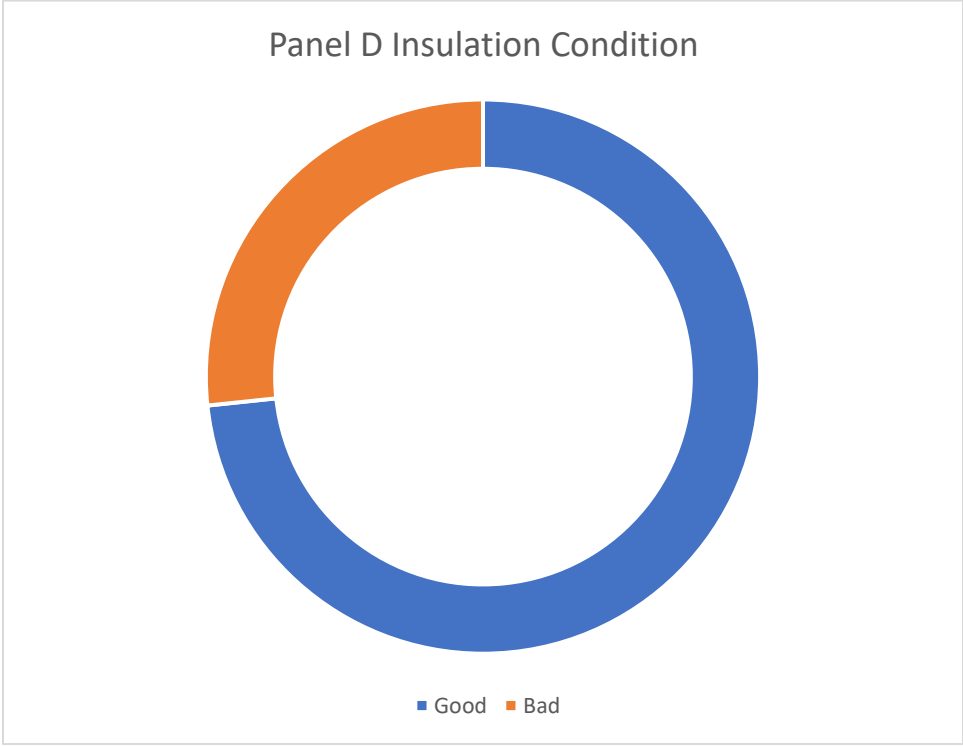
4.4.1 Audit Data

Only 18% of the heat trace components are in good condition, with 82% requiring immediate repair. The insulation components are mostly in good condition at 86%, but 14% need attention.

In summary, Panel D's heat trace system needs significant repairs, while the insulation system requires minor fixes to maintain overall efficiency.
