2024 AUDIT REPORT OF ELECTRICAL HEAT TRACE SYSTEMS

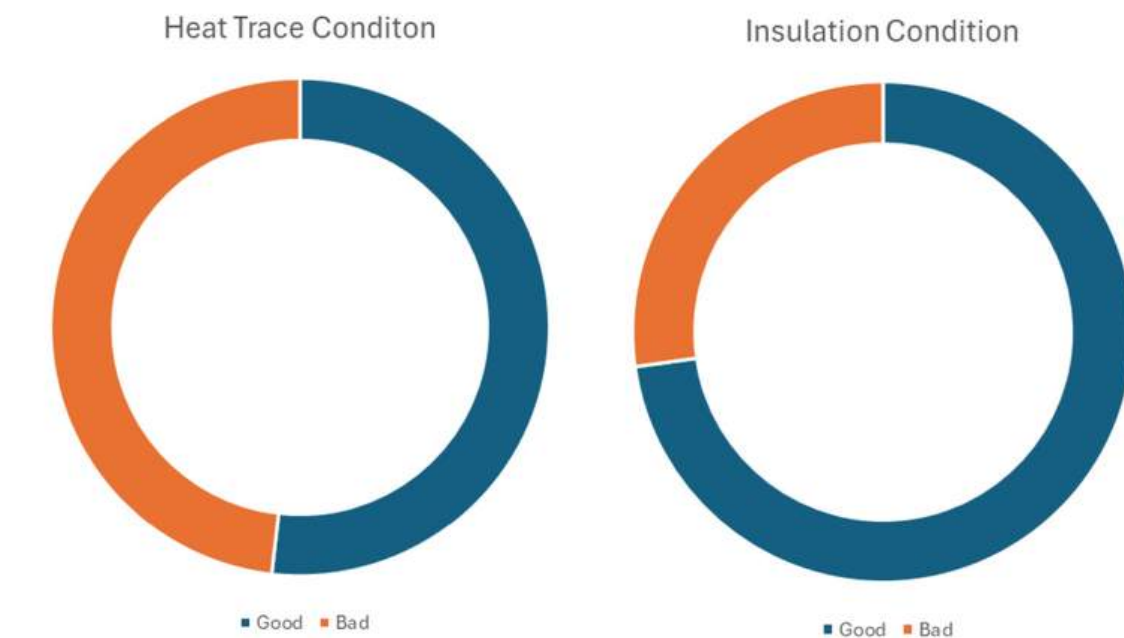
The evaluation indicates that 42% of the insulation elements are in good condition, while 22% are in bad condition. Additionally, 18% of the insulation elements are categorized as spares. For heat trace components, 28% are functioning as intended, 35% are in bad condition, and 18% are identified as spares.

These insights underscore the urgency of addressing the underperforming and deficient components to mitigate the risk of system failure. Prioritizing repairs and maintenance for the components in poor condition is crucial for enhancing the overall reliability and efficiency of the EFP system. Addressing these deficiencies will significantly improve the system's resilience against environmental challenges and restore its operational integrity.

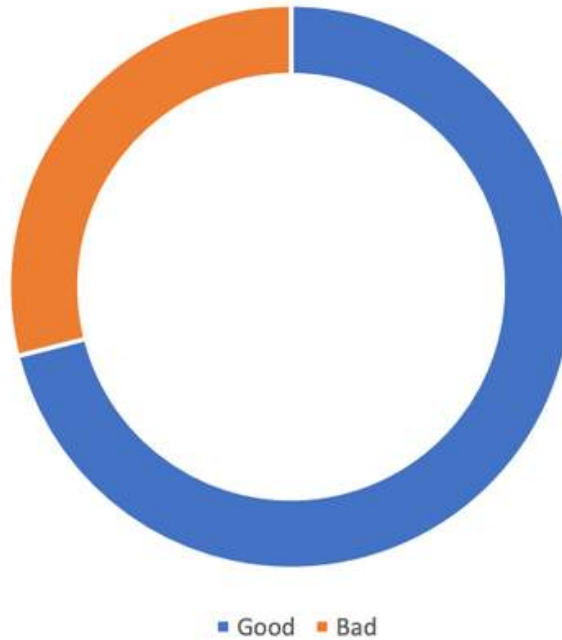
Panel A Insulation Condition

Only 28% of the heat trace components are in good condition, with 72% requiring immediate repair. The insulation components are mostly in good condition at 88%, but need 12% attention.

In summary, Panel A's heat trace system needs significant repairs, while the insulation system requires minor fixes to maintain overall efficiency.

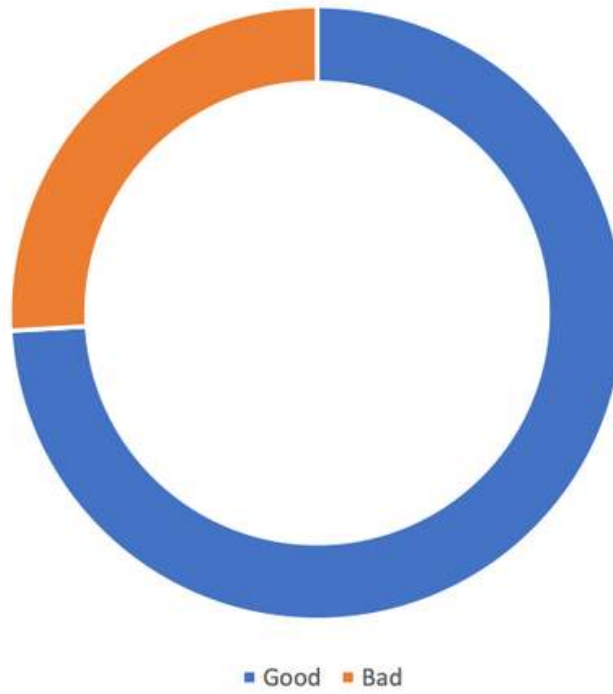
Panel B Insulation Condition

Only 14% of the heat trace components are in good condition, with 86% requiring immediate repair. The insulation components are mostly in good condition at 86%, but need 14% attention.

In summary, Panel B's heat trace system needs significant repairs, while the insulation system requires minor fixes to maintain overall efficiency.

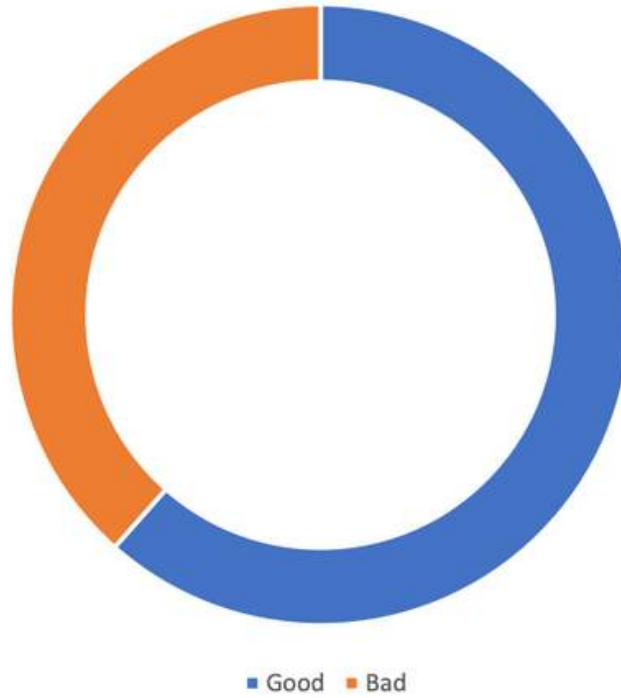
Panel C Heat Trace Conditon

Only 24% of the heat trace components are in good condition, with 76% requiring immediate repair. The insulation components are mostly in good condition at 86%, but need 14% attention.

In summary, Panel C's heat trace system needs significant repairs, while the insulation system requires minor fixes to maintain overall efficiency.

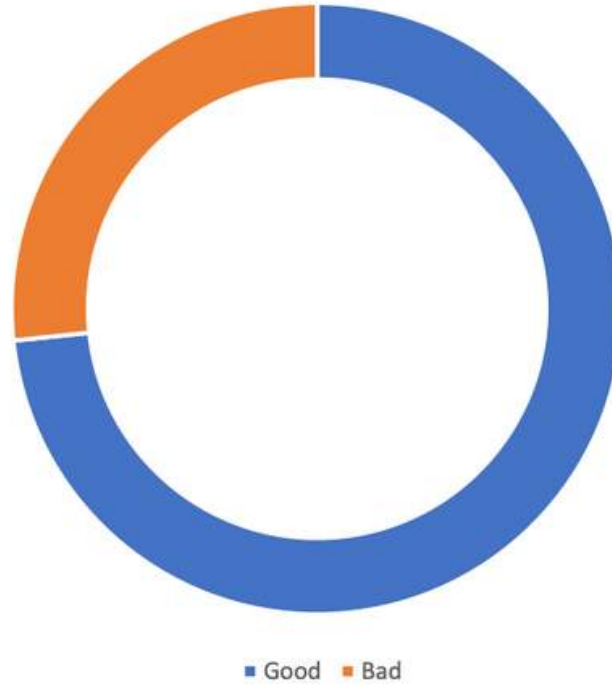
Panel D Heat Trace Conditon

Only 18% of the heat trace components are in good condition, with 82% requiring immediate repair. The insulation components are mostly in good condition at 86%, but need 14% attention.

In summary, Panel D's heat trace system needs significant repairs, while the insulation system requires minor fixes to maintain overall efficiency.
