2024 AUDIT REPORT OF ELECTRICAL HEAT TRACE SYSTEMS

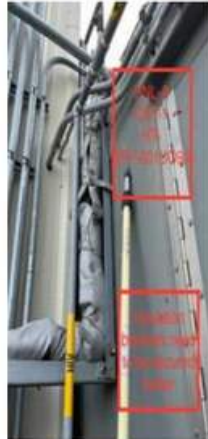
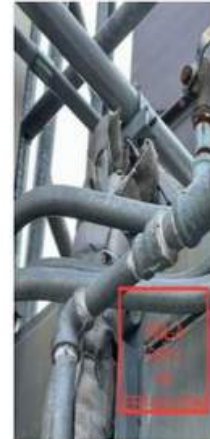
4.1.2 PICTURES

Only 28% of the heat trace components are in good condition, with 72% requiring immediate repair. The insulation components are mostly in good condition at 88%, but need 12% attention.

In summary, Panel A's heat trace system needs significant repairs, while the insulation system requires minor fixes to maintain overall efficiency.
